Manhole Inspection Summary

Manhole # S51C2_010MH

Insp Date: **6/25/08 11:29 AM**

Location Address: **1701 W. Patapsco Ave.**

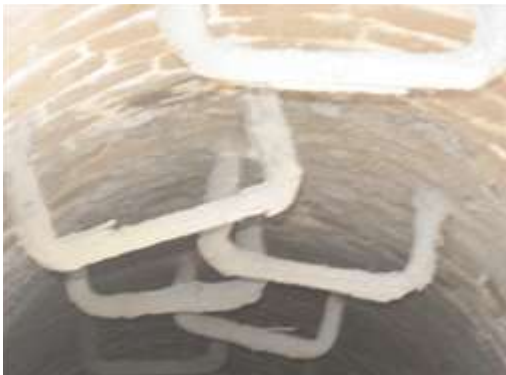
Steps

Count: **20** Missing: **0** ☒ **Corroded**

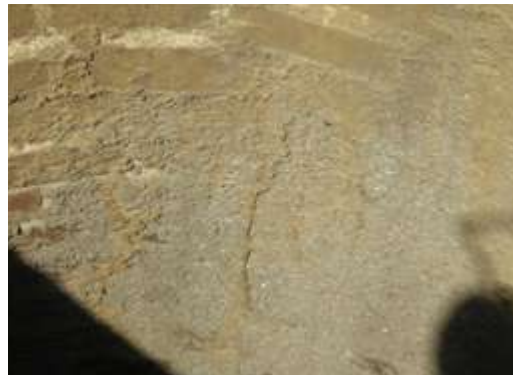
Defect 1

Condition: ☐ Sound ☐ Cracked ☐ Root Intrusion ☐ Loose Brick ☒ **Deteriorated**

Infiltration: ☐ None ☐ Joint ☐ Cracks ☐ Mortar ☐ Roots ☒ **Wall**

Infiltration
